**Flood Control Project Maintenance
Levee Inspections**

Fall 2016 Levee Maintenance Deficiency Summary Report

Reclamation District No. 2060 Hastings

Levee Inspection Report By Mile - Fall 2016

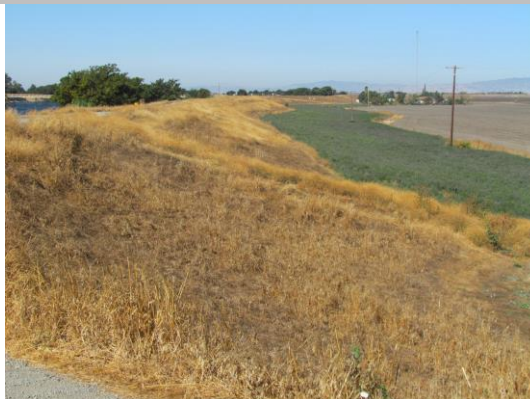
Photo 1 of 1 : FA_2016_RD2060_241_5_20160920_00006.jpg

LM Start	0.00	Rating **	M	Issue No.	5
LM End	5.08	Issue Type +	Ma	Location *	LS
Category	Earthen Levee			GPS Latitude/Longitude	
				Start	End
Item	Vegetation			38.247342 °	38.263293 °
				-121.696283 °	-121.771557 °
DWR ID	DWR_RD2060_01_f_2016_5				
Comment Code					
V1 : Control annual grass and weeds on the levee slopes and easements.					
Inspector Comment					
Landside levee slope has been sprayed, sprayed grasses has not been removed from slope.

RD 2060 Landside slope looking downstream from levee mile 0.00.

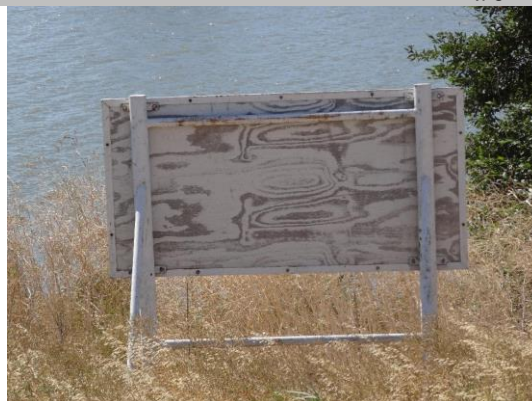
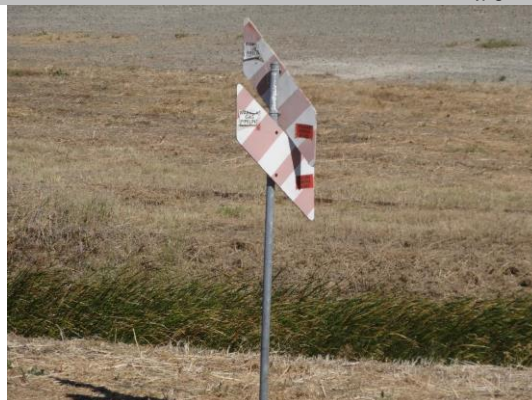
LM Start	3.65	Rating **	M	Issue No.	16
LM End	3.65	Issue Type +	En	Location *	WS
Category	Supplemental			GPS Latitude/Longitude	
				Start	End
Item	DWR UCIP Field Study			38.261314 °	38.261314 °
				-121.749191 °	-121.749191 °
DWR ID					
Comment Code					
Inspector Comment					
FS_ID:41908 DS_ID:22050 EP_NO: 10119 Repair Type: Non-Urgent Crossing Status: Indicator Found UCIP Comments: Need to contact owner and verify status of crossing. FIELD_STRUCT_DESC: 8-5/8-inch gas pipeline crosses Lindsey Slough to R.D. 536. Gasline marker on LS and sign board on WS. (Permit no. 10119) FS Date: 8/15/2013

WS view: gasline sign board on levee slope.

LS view: gasline indicator across the road from levee toe.

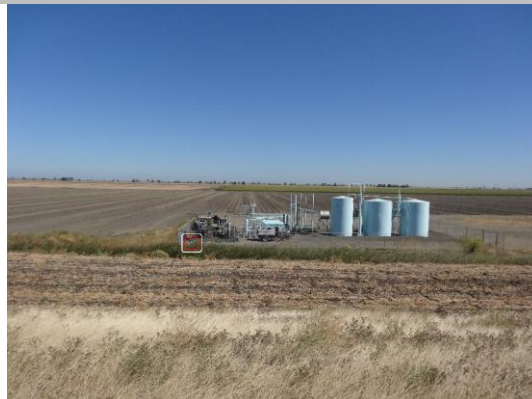
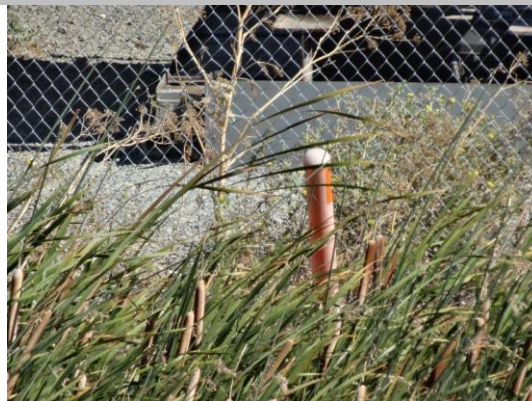
LM Start	3.76	Rating **	M	Issue No.	15
LM End	3.76	Issue Type +	En	Location *	WS
Category	Supplemental			GPS Latitude/Longitude	
				Start	End
Item	DWR UCIP Field Study			38.261211 °	38.261211 °
				-121.751117 °	-121.751117 °
DWR ID					
Comment Code					
Inspector Comment					
FS_ID:41878 DS_ID:22045 EP_NO: 12784 Repair Type: Non-Urgent Crossing Status: Indicator Found UCIP Comments: Need to contact owner to determine status and install signs if appropriate. FIELD_STRUCT_DESC: 8.625-inch diameter natural gas pipeline across the channel and both levees of Lindsey Slough. 4 feet below the crown. Gasline marker found off LS (Permit No. 12784). FS Date: 8/15/2013

LS view: a gas plant and gasline indicator found on LS.

LS view: closer view of gasline indicator found on LS.

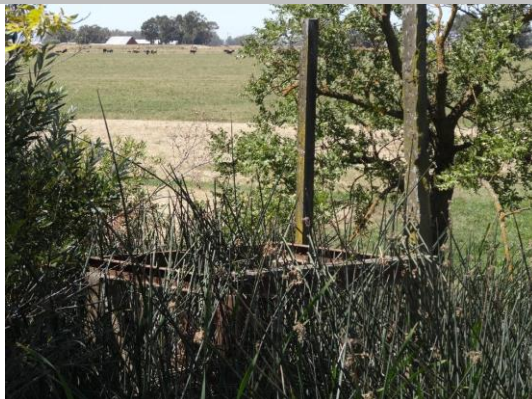
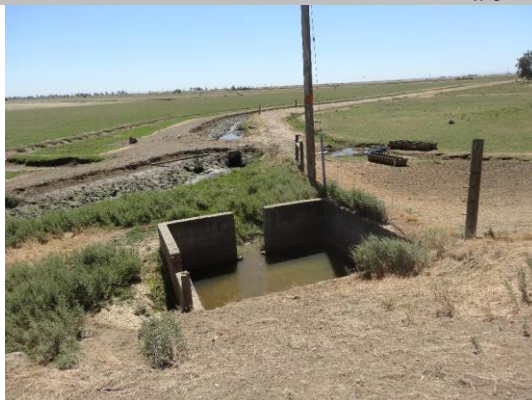
FS_ID:46769
DS_ID:22059
EP_NO: N/A
Repair Type: Non-Urgent
Crossing Status: Indicator Found
UCIP Comments: - Abandoned pump structure in stream needs proper abandonment- Not accessible due to wired fence
FIELD_STRUCT_DESC: *ABANDONED* pump structure in stream and a concrete distribution on landside. Not accessible due to wired fence.
FS Date: 8/15/2013

WS view: abandoned pump support in stream/channel. Not accessible due to vegetation.

LS view: abandoned concrete distribution box. Not accessible due to wire fence.

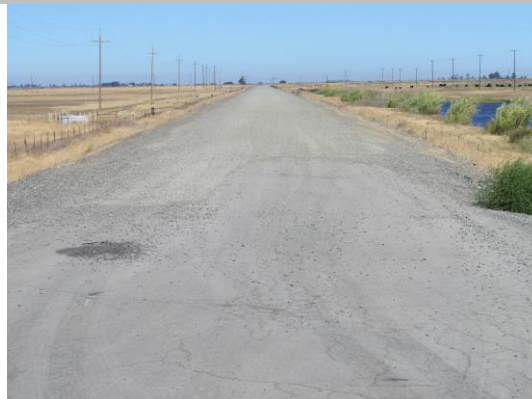
Photo 1 of 1 : FA_2016_RD2060_242_8_20160920_00010.jpg

LM Start	0.01	Rating **	A	Issue No.	8
LM End	3.64	Issue Type +	Ma	Location *	LS
Category	Earthen Levee			GPS Latitude/Longitude	
				Start	End
Item	Vegetation			38.275082 °	38.296645 °
				-121.794938 °	-121.748772 °
DWR ID	DWR_RD2060_02_f_2016_8				
Comment Code					
V1 : Control annual grass and weeds on the levee slopes and easements.					
Inspector Comment					
There are no unwanted weeds or vegetation on the levee section both waterside and landside.

Looking downstream from levee mile 0.01 Unit 2 RD 2060.

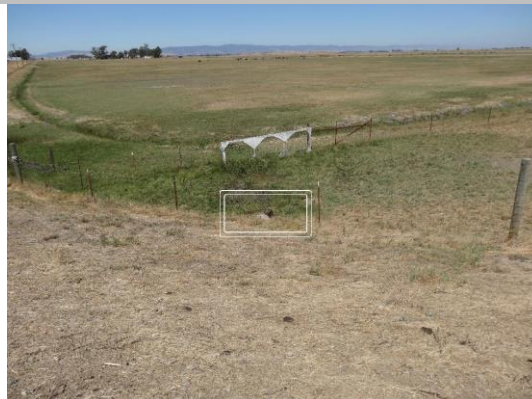
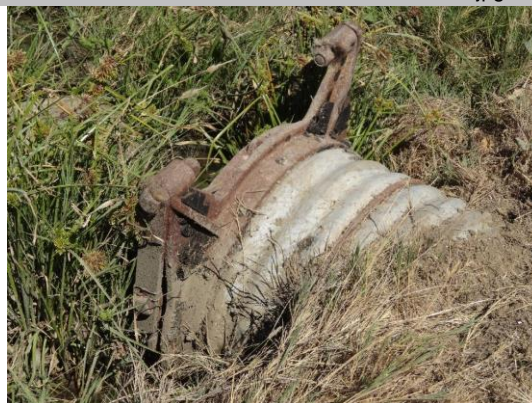
LM Start	1.74	Rating **	M	Issue No.	11
LM End	1.74	Issue Type +	En	Location *	WS
Category	Supplemental			GPS Latitude/Longitude	
				Start	End
Item	DWR UCIP Field Study			38.285219 °	38.285219 °
				-121.777085 °	-121.777085 °
DWR ID					
Comment Code					
Inspector Comment					
FS_ID:18386					
DS_ID:22056					
EP_NO: 10148					
Repair Type: Non-Urgent					
Crossing Status: Found					
UCIP Comments: U-type concrete headwall on LS. Not accessible due to fence. Vegetation is partially blocking inlet & outlet pipe.					
FIELD_STRUCT_DESC: 24-inch CM drainpipe through levee, 16.0 feet below crown, flap gate on waterward end. U-type concrete headwall on LS. Not accessible due to fence. Vegetation is partially blocking inlet & outlet pipe.					
FS Date: 8/15/2013

WS view: overview of CMP from levee.

WS view: CM pipe with flap gate. Not accessible. Vegetation is partially blocking outlet pipe.

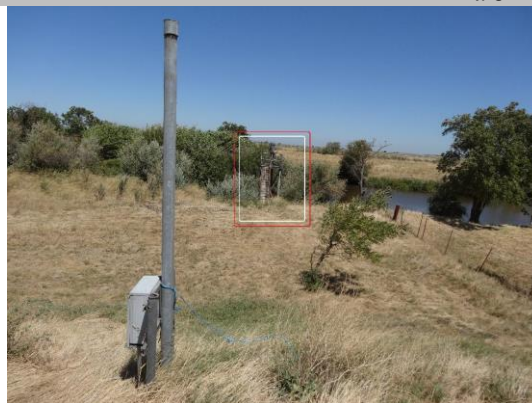
Photo 1 of 2 : UCIP_FA_2016_41668_31161.jpg

LM Start	2.15	Rating **	M	Issue No.	12
LM End	2.15	Issue Type +	En	Location *	LS
Category	Supplemental			GPS Latitude/Longitude	
				Start	End
Item	DWR UCIP Field Study			38.290440 °	38.290440 °
				-121.774808 °	-121.774808 °
DWR ID					
Comment Code					
Inspector Comment					
FS_ID:41668					
DS_ID:22060					
EP_NO: 5927					
Repair Type: Non-Urgent					
Crossing Status: Found					
UCIP Comments: verify pipe has been abandoned properly. -					
abandoned pump and pipe.- electrical box on WS shoulder.					
FIELD_STRUCT_DESC: *Abandoned* 18-inch steel pipe through levee					
4.0 feet below crown, siphon breaker on landward slope. Pump on piling					
on bank, distribution box at landward toe. (Permit No. 5927 - Cache					
Slough Pheasant Club).					
FS Date: 8/15/2013

WS view: electrical box on pole and pump structure in background.

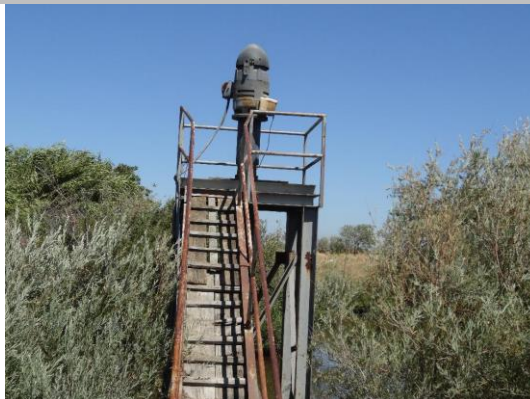
Photo 2 of 2 : UCIP_FA_2016_41668_31160.jpg

LM Start	2.15	Rating **	M	Issue No.	12 (cont)	
LM End	2.15	Issue Type +	En	Location *	LS	
Category	Supplemental			GPS Latitude/Longitude		
				Start	End	
Item	DWR UCIP Field Study			38.290440 °	38.290440 °	
				-121.774808 °	-121.774808 °	
DWR ID						
Comment Code						
Inspector Comment						
FS_ID:41668						
DS_ID:22060						
EP_NO: 5927						
Repair Type: Non-Urgent						
Crossing Status: Found						
UCIP Comments: verify pipe has been abandoned properly. -						
abandoned pump and pipe.- electrical box on WS shoulder.						
FIELD_STRUCT_DESC: *Abandoned* 18-inch steel pipe through levee						
4.0 feet below crown, siphon breaker on landward slope. Pump on piling						
on bank, distribution box at landward toe. (Permit No. 5927 - Cache						
Slough Pheasant Club).						
FS Date: 8/15/2013

WS view: pump on pile structure with stairs on bank.

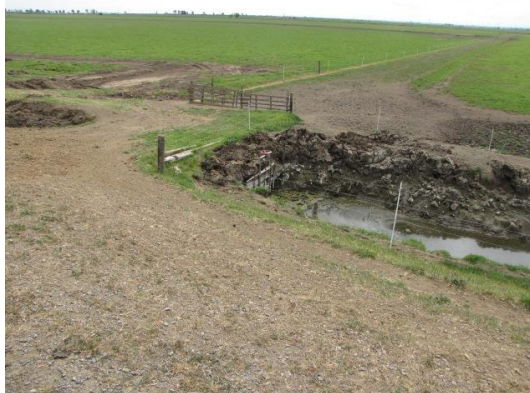
Photo 1 of 1 : FA_2016_RD2060_242_6_20160913_00001.jpg

LM Start	2.22	Rating **	M	Issue No.	6
LM End	2.22	Issue Type +	En	Location *	LS
Category	Earthen Levee			GPS Latitude/Longitude	
				Start	End
Item	Encroachments			38.290475 °	38.290475 °
				-121.773390 °	-121.773390 °
DWR ID	DWR_RD2060_02_s_2013_6				
Comment Code					
DT : Ditch					
Inspector Comment					
This ditch used for irrigation is not a new issue.

This ditch encroaches within the 10-foot easement. Photo taken 3-28-2013. No new photo was taken of this ditch during the Spring Inspection of 2014.

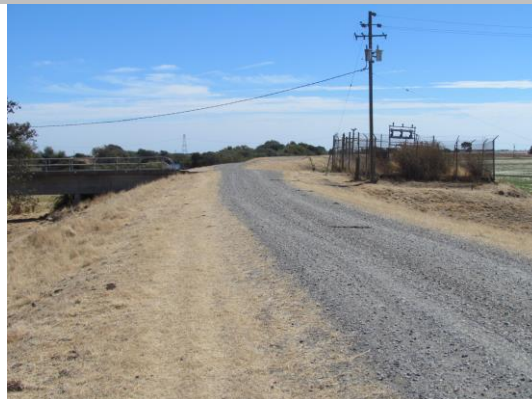
Photo 1 of 1 : FA_2016_RD2060_243_13_20160920_00016.jpg

LM Start	0.01	Rating **	A	Issue No.	13
LM End	3.50	Issue Type +	Ma	Location *	LS
Category	Earthen Levee			GPS Latitude/Longitude	
				Start	End
Item	Vegetation			38.296638 °	38.267223 °
				-121.748655 °	-121.702818 °
DWR ID	DWR_RD2060_03_f_2016_13				
Comment Code					
V1 : Control annual grass and weeds on the levee slopes and easements.					
Inspector Comment					
No unwanted vegetation on the levee slopes.

RD 2060 Looking downstream from levee mile 0.01 waterside slope.

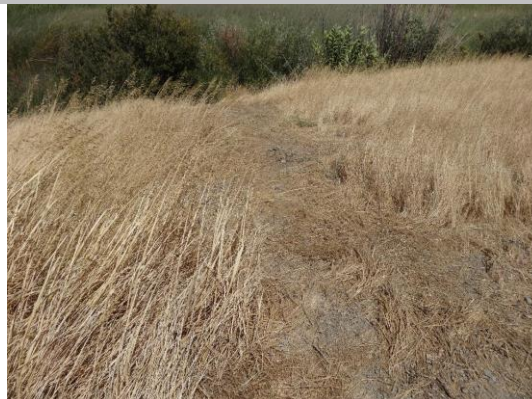
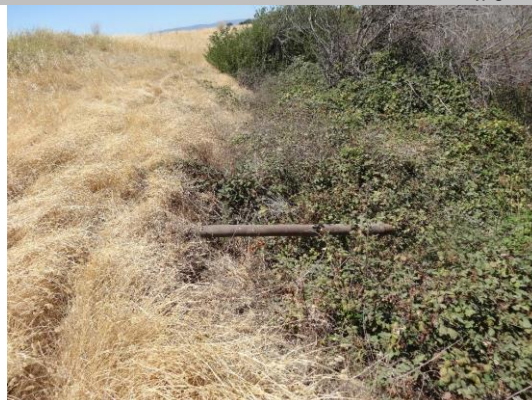
FS_ID:18727
DS_ID:22067
EP_NO: N/A
Repair Type: Non-Urgent
Crossing Status: Found
UCIP Comments: Seem abandoned. Not found- pump on LS. Needs more exploration.
FIELD_STRUCT_DESC: 6-inch steel pipe through the levee, 2.8 feet below the crown. O&M Manual SAC 107, April 1959.
FS Date: 8/15/2013

Waterside view: levee slope.

Waterside view: levee slope and a steel pipe.

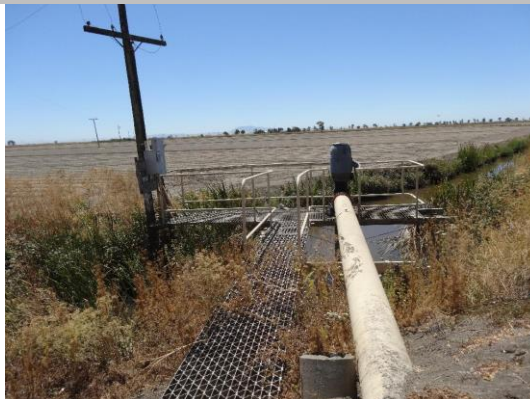
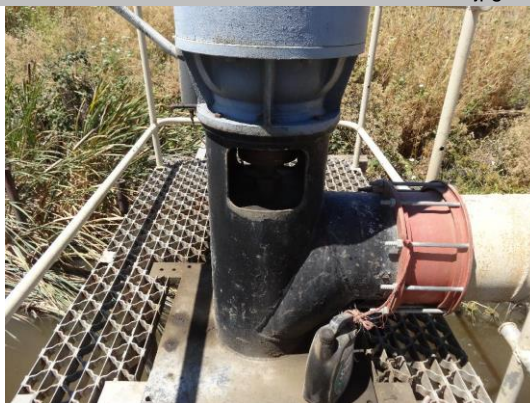
LM Start	0.90	Rating **	M	Issue No.	17
LM End	0.90	Issue Type +	En	Location *	WS
Category	Supplemental			GPS Latitude/Longitude	
				Start	End
Item	DWR UCIP Field Study			38.290684 °	38.290684 °
				-121.735639 °	-121.735639 °
DWR ID					
Comment Code					
Inspector Comment					
FS_ID:18726					
DS_ID:22063					
EP_NO: 6342					
Repair Type: Non-Urgent					
Crossing Status: Found					
UCIP Comments: Leaky siphon breaker may need to be repaired.					
Dense vegetation on WS.Not found- gate valve on LS.					
FIELD_STRUCT_DESC: 16-inch steel pipe through levee 8.0 feet below crown, vertical pump in drain ditch on land-side. Siphon breaker on waterside. (App. No. 6342-A - Hastings Farms)					
FS Date: 8/15/2013

Landside view: pump, service pole, steel support structure, walkway, and pipe.

Landside view: pipe and pump on steel structure in drain ditch.

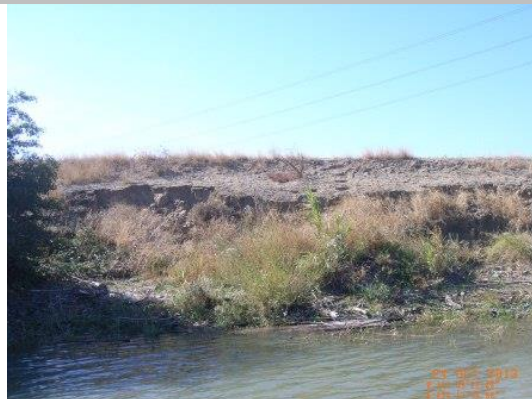
USACE 2013 Photo #1

LM Start	1.52	Rating **	M	Issue No.	8
LM End	1.74	Issue Type +	Ma	Location *	WS
Category	Supplemental			GPS Latitude/Longitude	
				Start	End
Item	2015 USACE Erosion Survey, DRAFT			38.288598 °	38.286051 °
				-121.725184 °	-121.722818 °
DWR ID	DWR_RD2060_03_s_2016_8				
Comment Code					
Inspector Comment					
Site added in 1997 and removed in 2003. 2005 - Put back in the inventory. 2006 - Stone repair at the middle of the site. 2011 - Some rock place at toe in the past year. 2013 - Site extended both upstream and downstream to include new erosion pockets. 2015: No observed changes. [2015 Site ID: CHS_23-6_R]

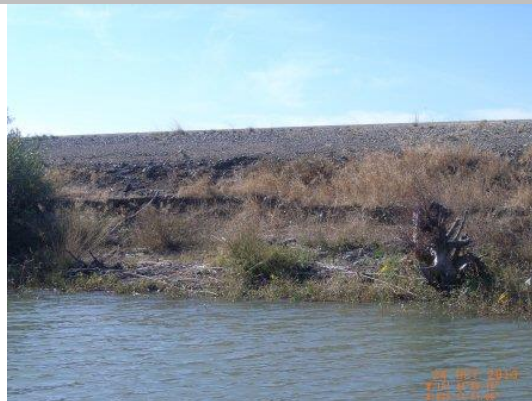
USACE 2013 Photo #1

LM Start	2.02	Rating **	M	Issue No.	1
LM End	2.08	Issue Type +	Ma	Location *	WS
Category	Supplemental			GPS Latitude/Longitude	
				Start	End
Item	2015 USACE Erosion Survey, DRAFT			38.284105 °	38.283302 °
				-121.718471 °	-121.717814 °
DWR ID	DWR_RD2060_03_s_2016_1				
Comment Code					
Inspector Comment					
2010 - Small maintenance site. 2015: No observed changes. [2015 Site ID: CHS_23-0_R]

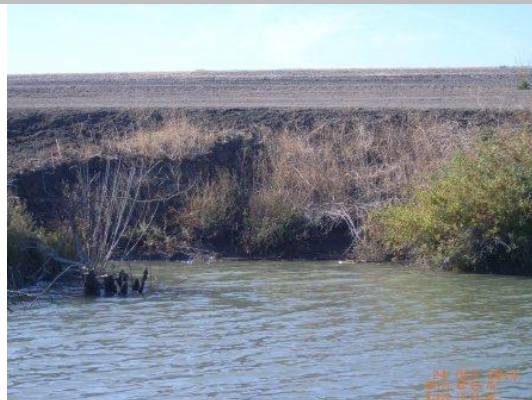
USACE 2013 Photo #1

LM Start	2.18	Rating **	M	Issue No.	7
LM End	2.23	Issue Type +	Ma	Location *	WS
Category	Supplemental			GPS Latitude/Longitude	
				Start	End
Item	2015 USACE Erosion Survey, DRAFT			38.282100 °	38.281510 °
				-121.716817 °	-121.716319 °
DWR ID	DWR_RD2060_03_s_2016_7				
Comment Code					
Inspector Comment					
2007 - Geotechnical failure of midside slope and wave wash/scalloping in toe area. Stone revetment upstream and downstream of site. Similar sites are present all along the right bank downstream of this site, most could be repaired with some maintenance. 2010 - Minor new erosion. 2015: No observed changes. [2015 Site ID: CHS_22-8_R]

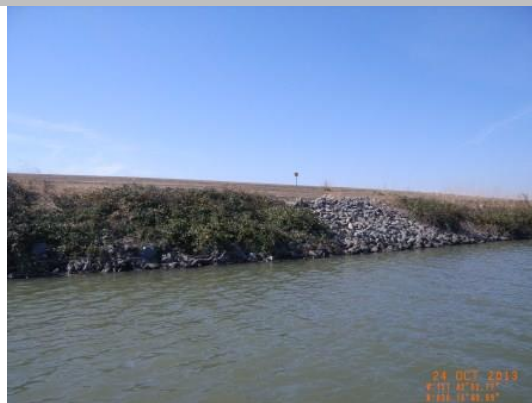
USACE 2013 Photo #1

LM Start	2.35	Rating **	M	Issue No.	4
LM End	2.53	Issue Type +	Ma	Location *	WS
Category	Supplemental			GPS Latitude/Longitude	
				Start	End
Item	2015 USACE Erosion Survey, DRAFT			38.280377 °	38.278306 °
				-121.714633 °	-121.712722 °
DWR ID	DWR_RD2060_03_s_2016_4				
Comment Code					
Inspector Comment					
2008 - Small scour pockets and mid-slope wave wash. 2010 - More vegetation growth, could be fixed through maintenance. 2011 - Site extended downstream and new erosion. 2015: No observed changes. [2015 Site ID: CHS_22-6_R]

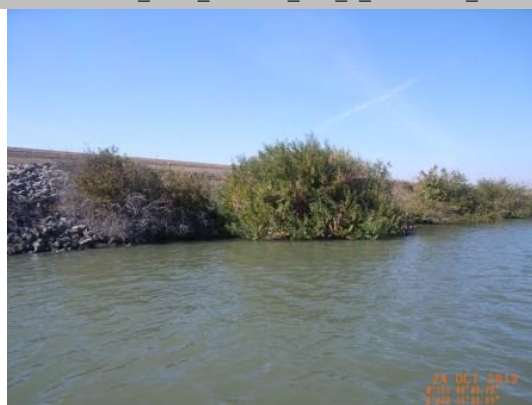
USACE 2013 Photo #1

LM Start	2.55	Rating **	M	Issue No.	5
LM End	2.58	Issue Type +	Ma	Location *	WS
Category	Supplemental			GPS Latitude/Longitude	
				Start	End
Item	2015 USACE Erosion Survey, DRAFT			38.278145 °	38.277774 °
				-121.712609 °	-121.712137 °
DWR ID	DWR_RD2060_03_s_2016_5				
Comment Code					
Inspector Comment					
2013 - Erosion pockets into the levee toe. 2015: Erosion pockets have increased in size. [2015 Site ID: CHS_22-5_R]

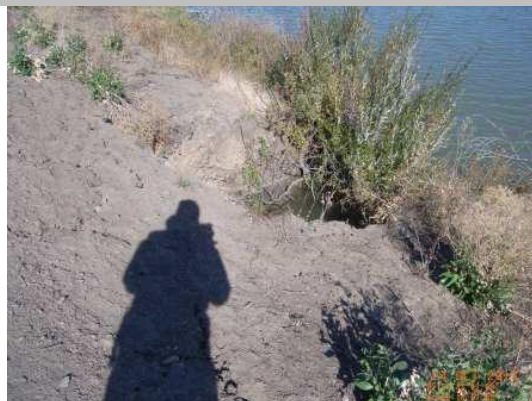
USACE 2013 Photo #1

LM Start	2.79	Rating **	M	Issue No.	6
LM End	2.79	Issue Type +	Ma	Location *	LS
Category	Earthen Levee			GPS Latitude/Longitude	
				Start	End
Item	Slope Stability			38.275302 °	38.275302 °
				-121.710130 °	-121.710127 °
DWR ID	DWR_RD2060_03_s_2016_6				
Comment Code					
S1 : Repair slope instability.					
Inspector Comment

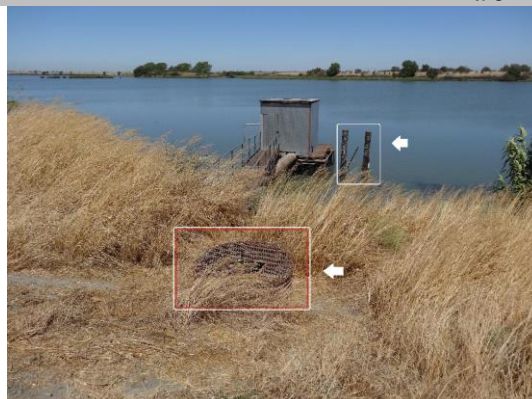
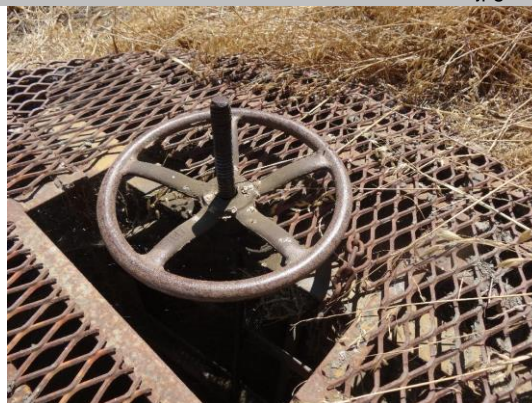
LM Start	3.24	Rating **	M	Issue No.	16
LM End	3.24	Issue Type +	En	Location *	WS
Category	Supplemental			GPS Latitude/Longitude	
				Start	End
Item	DWR UCIP Field Study			38.270151 °	38.270151 °
				-121.705782 °	-121.705782 °
DWR ID					
Comment Code					
Inspector Comment					
FS_ID:18723					
DS_ID:22064					
EP_NO: N/A					
Repair Type: Non-Urgent					
Crossing Status: Indicator Found					
UCIP Comments: Only a CMP riser was found on WS.					
FIELD_STRUCT_DESC: Only a CMP riser was found WS. All other features not found as described: 36-inch steel pipe through levee 15.0 feet below crown, slide gate in CM riser on waterward slope. (Asbestos bonded pipe.) Pump in pump house on pile structure in stream. Service pole and anchor on landward slope. Only a CMP riser was found WS.					
FS Date: 8/15/2013

WS view: slide gate in CMP riser (bottom- marked) and may be abandoned pile for pump support (marked- right).

WS view: closer view of slide gate in CMP riser.

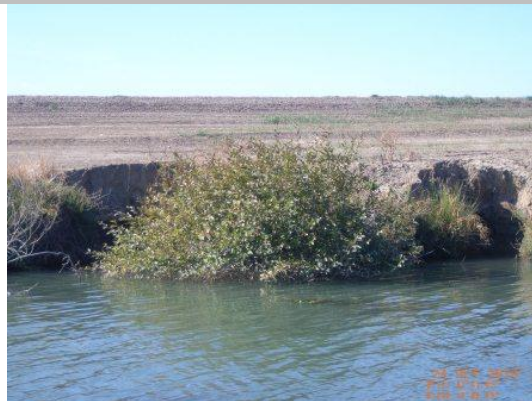
USACE 2013 Photo #1

LM Start	3.78	Rating **	M	Issue No.	2
LM End	4.09	Issue Type +	Ma	Location *	WS
Category	Supplemental			GPS Latitude/Longitude	
				Start	End
Item	2015 USACE Erosion Survey, DRAFT			38.264585 °	38.260593 °
				-121.698868 °	-121.696403 °
DWR ID	DWR_RD2060_03_s_2016_2				
Comment Code					
Inspector Comment					
2011 - Several pockets of erosion from rotational failure and slumping toe. 2013 - Site extended downstream to include new erosion pockets. 2015: No observed changes. [2015 Site ID: CHS_21-1_R]
